September 15, 2016

Observe for possible fluid leakage when preparing parenteral syringes

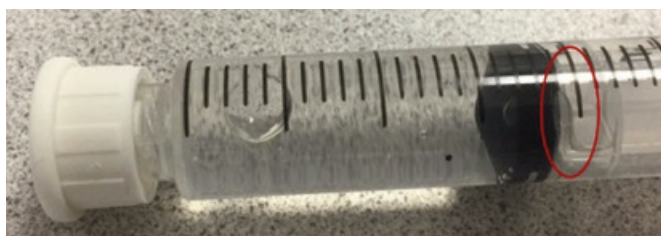
The Institute for Safe Medication Practices (ISMP) has heard from three hospitals about occasional instances of medication leaking from syringes. Leaks have extended past the first and second rib on the black stopper on the parenteral syringe plunger rod into the surface of the syringe barrel that is exposed to air (**Figure 1**). The situation appears to occur as liquid is drawn into the syringe rather than after the syringe has been filled. In some cases, personnel said that it has happened rarely, and they may not have realized the situation was out of the ordinary, so instances may have gone unreported.

In assessments BD has made, the company found that leakage into the area between the first and second ribs of the stopper retains the sterility of the fluid and in most instances has no impact on the volumetric accuracy of the delivery of the medication.

Figure 1. Medication or solutions drawn into this syringe have leaked below the black plunger (circled in red), which may pose a problem with sterility and safe handling of hazardous drugs.

larger syringe sizes (e.g., 30 mL and 60 mL). As a syringe is being filled with the vial inverted and the syringe below the vial, there may be a tendency to pull the plunger rod at an angle toward the user and not always maintain a vertical alignment with the syringe barrel. With an increased amount of fluid in the syringe, the ribs of the stopper may be angled enough to cause leakage past the stopper ribs. BD says that it is always important to ensure vertical alignment of the plunger rod with the syringe barrel when withdrawing a solution using this inverted vial technique.

ISMP recommends sharing this information with sterile syringe production personnel and clinical personnel who prepare medications in parenteral syringes. Ask them to always observe prepared syringes for this situation.

If leakage is observed beyond the first and second ribs of the stopper and into the area exposed to air, the syringe and medication may have been contaminated and should not be used. Additional precautions to avoid contaminating work surfaces and exposing personnel are required if leaking syringes contain hazardous drugs.

If a leaking syringe is identified, the syringe lot number should be identified and recorded, and such instances should be reported to the FDA MedWatch Program (www.ismp.org/sc?id=1660), the ISMP National Medication Errors Reporting Program (MERP) (www.ismp.org/MERP), and the syringe manufacturer.
