Nurse AdviseERR®

Do not let “Depo-” medications be a depot for mistakes

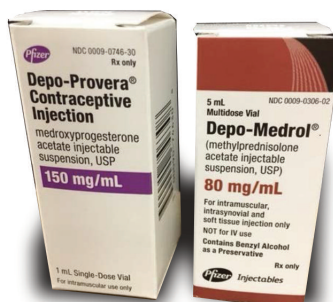
In early 2015, FAERS received a report involving a 44-year-old man with shoulder pain (non-impingement) who received an intra-articular injection of Depo-Provera instead of Depo-Medrol. A box of Depo-Provera had been stored inadvertently in the bin where Depo-Medrol was usually kept in a medication cabinet. Other than size, the medication cartons do not look similar, but both drug names start with “Depo-...” and appear in the same black font (**Figure 1**). The physician performing the shoulder injection reached into the bin and removed a box of the correct medication, Depo-Medrol, and read the label and concentration. He set that carton aside, and a moment later, he inadvertently reached back into the bin and removed another box, but this one contained Depo-Provera. Believing he had previously confirmed the drug and concentration, the physician withdrew the desired amount of an opaque white liquid similar in appearance to Depo-Medrol (**Figure 2**, page 2).

Figure 1. Both “Depo-” products have been mixed up, despite dissimilar carton labels.

- ✓ **Keep vials apart.** Separate the storage of Solu-MEDROL, Depo-Medrol, and Depo-Provera vials in the pharmacy and in all clinical settings where these drugs are stocked. Store only one medication in each bin or other storage container. Evaluate whether all three drugs need to be stocked in patient care units.

- ✓ **Differentiate products.** Ask pharmacy to consider stocking Depo-Provera in pre-filled syringes for single patient use instead of single-dose vials. Depo-SubQ Provera 104 is available in single use 0.65 mL (104 mg) prefilled syringes for subcutaneous injections, and Depo-Provera 1 mL (150 mg) is available in prefilled syringes for intramuscular injections. Since Depo-Medrol is not supplied in prefilled syringes, this may increase differentiation between the two products, but only if staff know to expect Depo-Provera in a syringe. Thus, staff awareness is a necessary component of this differentiation strategy.

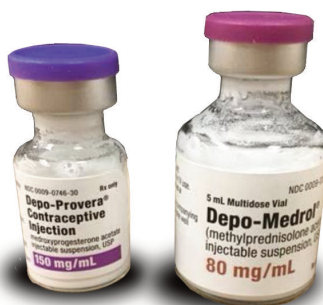
The physician injected about three-quarters of the 1 mL volume he had withdrawn into the syringe (about 112 mg of Depo-Provera). A medical assistant discovered the error while cleaning up after the patient had left the office. Within 3 days of the injection, the patient experienced a lack of libido and had erectile dysfunction, which required prolonged use of testosterone and **CIALIS** (tadalafil). Since making the error, the physician learned that others have made the same error, mixing up Depo-Medrol and Depo-Provera.

Figure 2. Vials look dissimilar except for the “Depo-” part of the drug name and the opaque white liquid inside the vial.

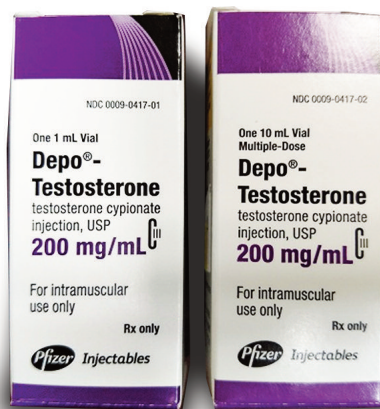
ISMP has received reports regarding potential errors with Depo-Testosterone for which the wrong strength or volume of the drug might be administered to patients. This drug is available in two strengths: 100 mg/mL and 200 mg/mL. The 200 mg/mL strength is available in a 1 mL vial and a 10 mL vial. However, the vial sizes are extremely hard to differentiate when looking at the medication cartons (**Figure 3**).

Figure 3. Can you see the difference? The labeling on cartons of Depo-Testosterone makes it difficult to notice that one contains a 1 mL vial (L) and the other a 10 mL vial (R).

- ✓ **Limit access.** Attempt to limit inventory of Depo-Testosterone to a single strength and vial size. Also evaluate which “Depo-” medications need to be stocked in patient care units, and limit access to those that can be dispensed as needed from the pharmacy.

- ✓ **Include auxiliary labels.** Highlight or circle important information on labels to draw attention to it, or add an auxiliary label if necessary. For example, given the small font of the warning on Depo-Medrol vials, an auxiliary label that states, “IM Use Only” or “Intra-articular Use Only” may be required. For Depo-Testosterone labels, continued on page 2—**check it out** >

circle or point an arrow toward the total volume in each vial.

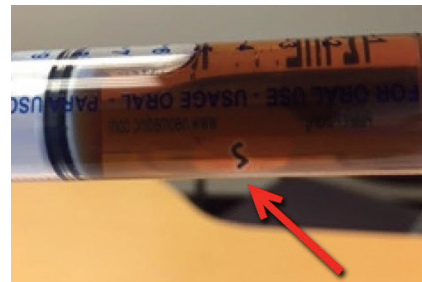
⚡ **“Floaters” in liquid melatonin.** We received a report about floating numbers found in liquid melatonin. Pharmacists preparing doses of Natrol Melatonin 1 mg/4 mL in oral syringes saw what appears to be the number 2 or 5 floating in the filled syringe (**Figure 1**, top of page 3). Appar-
continued on page 3—**SAFETY wires** >

ently, some of the numbers came off the dropper and were floating inside the 60 mL bottle of melatonin and then drawn into an oral syringe! The pharmacist contacted the company and FDA, and so did we. The company is aware of the situation and has recalled the 60 mL product. Practitioners will be notified once the cause is deter-

Figure 1. A “floater” is seen in a pharmacy-prepared dose of melatonin.

mined. In the meantime, the organization that reported this issue is utilizing a different liquid product without a dropper.

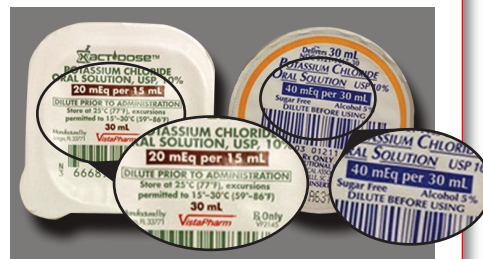
The labeling of VistaPharm potassium chloride oral solution 10% in unit dose cups is misleading as to the exact quantity in the container. The container prominently lists the strength as 20 mEq per 15 mL, but the cup actually contains 30 mL, or 40 mEq. The actual amount in milliequivalents is not stated. Other companies, including Pharmaceutical Associates, have safer labeling to indicate that the cup delivers either 15 or 30 mL and 20 or 40 mEq (**Figure 1**). We’ve contacted VistaPharm to suggest a label change

Figure 1. VistaPharm potassium chloride product (left) actually holds 40 mEq (30 mL), while the Pharmaceutical Associates product (right) lists the drug content in mEq per total volume.

that shows the exact quantity in the container (delivers 30 mL with strength of 40 mEq per 30 mL).

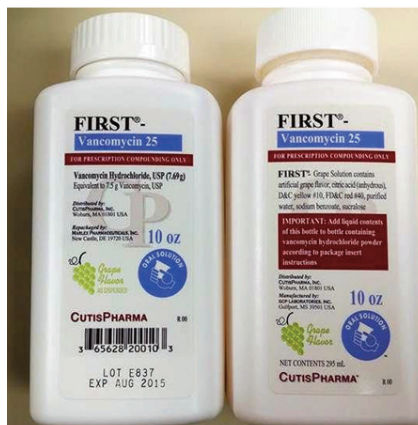
CutisPharma has begun to use for its **FIRST** brand vancomycin oral solution compounding kit. In the past, the diluent and powder container listed the drug name and strength at the top of both bottles (**Figure 1**), making it difficult to tell these apart. In fact, in our acute care newsletter, October 22, 2015 issue, we wrote about a nurse who gave only the diluent to her patient, thinking it contained the liquid vancomycin. It was not easy to tell the diluent container from the drug container without reading the full label with great care, which doesn't happen often enough!

Figure 1. Prior labeling allowed confusion between the diluent (R) and the vancomycin powder (L).

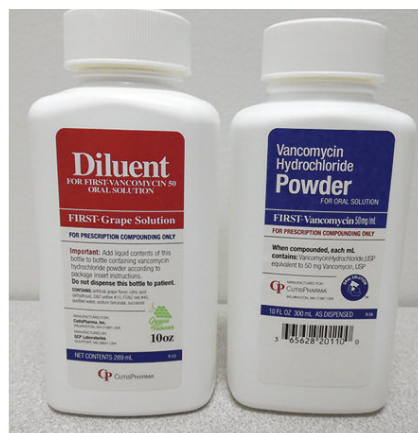
But now, CutisPharma has revised the container labels by doing what we suggested last fall: print "Diluent" in large, bold text on the diluent label and "vancomycin hydrochloride Powder" on the powder label (**Figure 2**). They also made distinct color changes to help make each container look different. These changes will likely help to avoid similar errors.

Figure 2. New labeling clearly differentiates the diluent (L) from the vancomycin powder (R).
