## ISMP Medication Safety Alert!®

## Smart pump custom concentrations without hard “low concentration” alerts can lead to patient harm

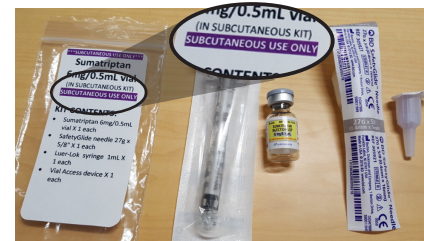
**Preventing SUMAtriptan injection wrong route errors.** On six occasions within a 4-month period in the same health system, **SUMAtriptan** has been given intravenously (IV) instead of subcutaneously. The errors have occurred in both large and small hospitals in the health system and in medical-surgical units and the emergency department (ED). Although the health system uses a barcode scanning medication administration system to verify that the right product at the right time is in hand for the right patient, the technology cannot detect if the drug is then administered by the wrong route. Most errors have occurred while practitioners are administering several IV medications to patients, and then have forgotten that **SUMAtriptan** should be administered sub-

**Figure 1.** SUMAtriptan kit contains materials for subcutaneous injection, including a subcutaneous needle.

To support correct subcutaneous administration, the health system is devising a kit that contains the drug vial, a 1 mL syringe, and a 27-gauge subcutaneous needle packaged in a small Ziploc bag. The bag has a label on the outside, stating the name and dose of the drug along with several distinct warning statements that it is intended for “SUBCUTANEOUS USE ONLY” (Figure 1, page 1). Other risk-reduction strategies include having pharmacy prepare and dispense syringes of **SUMAT**riptan as needed, with auxiliary labels to warn about subcutaneous use only, or stocking the nasal formulation of **SUMAT**riptan, which has a similar onset of action, in appropriate patient care areas such as the emergency department. Prompting nurses to document the location of the subcutaneous injection may also serve as a reminder that the drug should be administered by that route. There are also auto-injectors and pens available, but these are meant for self-injection by patients.
